Upgrading the Dundas Point Boardwalk, Applecross with the use of GFRP Bar Reinforced Concrete Columns and Footings

Joel Brown B.Eng GradIEAust
Structural Engineer, Airey Taylor Consulting

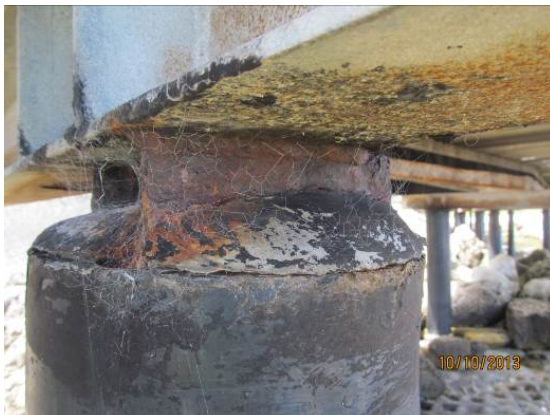
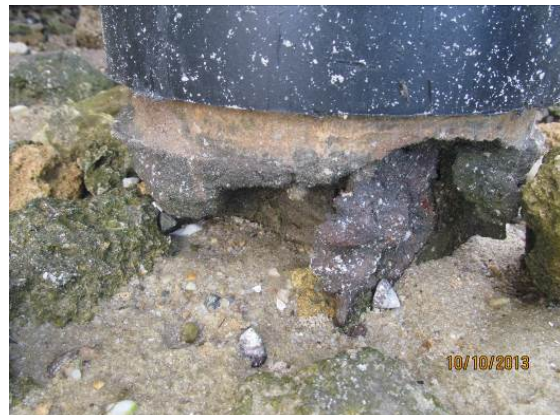
Figure 1. Left: Steel UC Connecting to Steel Framing. Right: Steel UC Below Concrete Encasing.

Steel thickness measurements were performed on a selection of the steel piles. They were assessed in accordance with AS 1627.0-1997: 'Metal finishing - Preparation and Pretreatment of Surfaces (3). All piles were classified as suffering from Grade H corrosion –'Large portion of surface is covered with rust, pits, rust nodules and non-adherent paint, pitting is visible.' The results of the thickness measurements were extrapolated through a detailed non-destructive visual inspection to give an assessment of all 76 of the boardwalk piles, Table 1 summarises these results.

The proposed solution included the replacement of pile supports whilst keeping a portion of the embedded steel UC pile to provide added anchorage of the element into the ground. The existing concrete encasement to piles was to be fully removed and replaced with a durable GFRP reinforced concrete solution. Whilst the existing steel UC pile was engaged, its requirement was designed out in the final design. This meant that a new footing would be required to support the concrete columns.

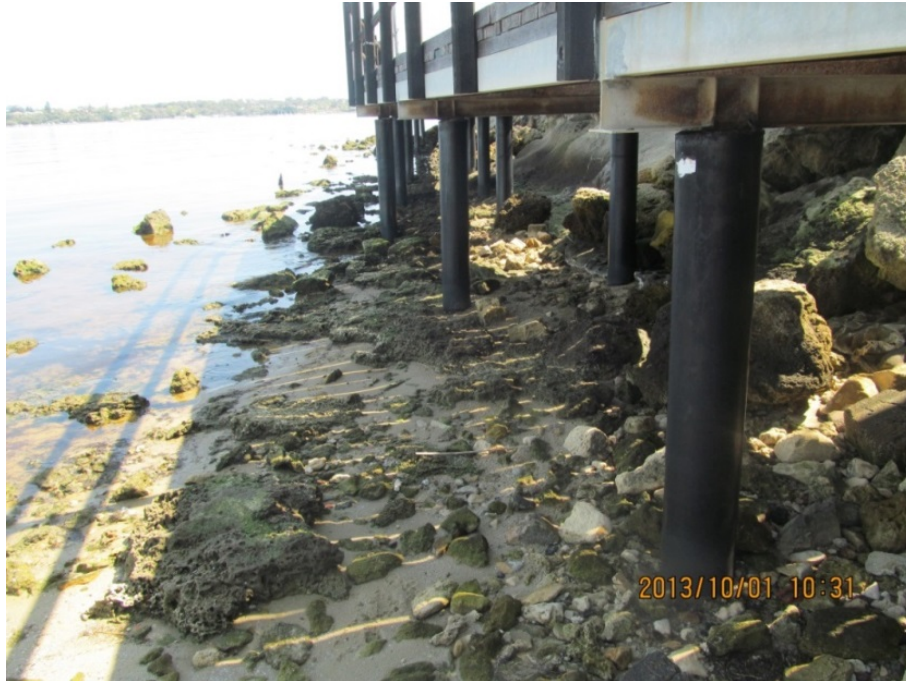
Figure 2. Existing Boardwalk in Tidal Zone.

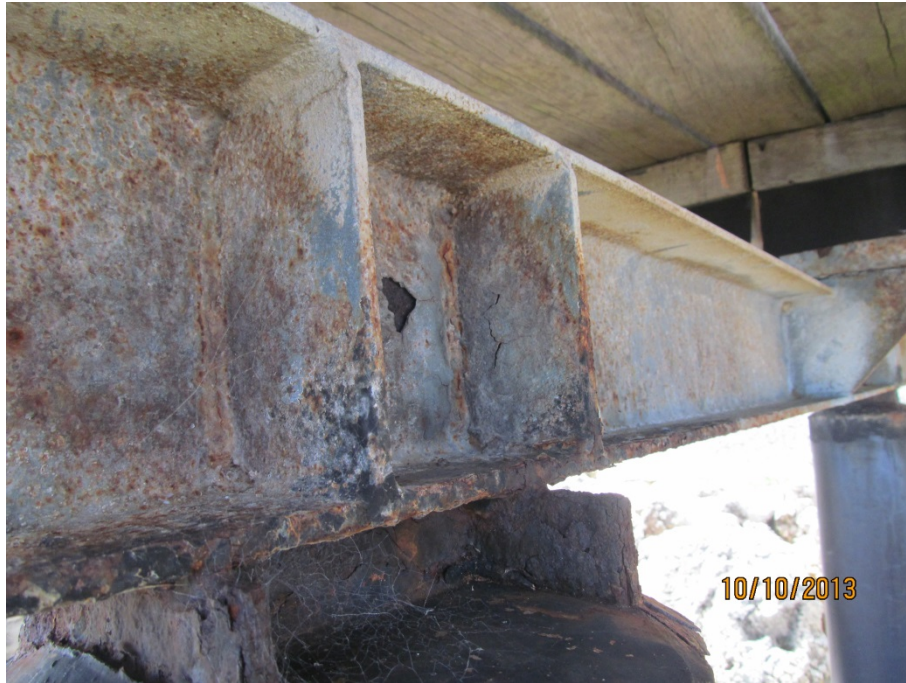
Figure 3. Typical Arrangement of Two Piles and Cross Beam.

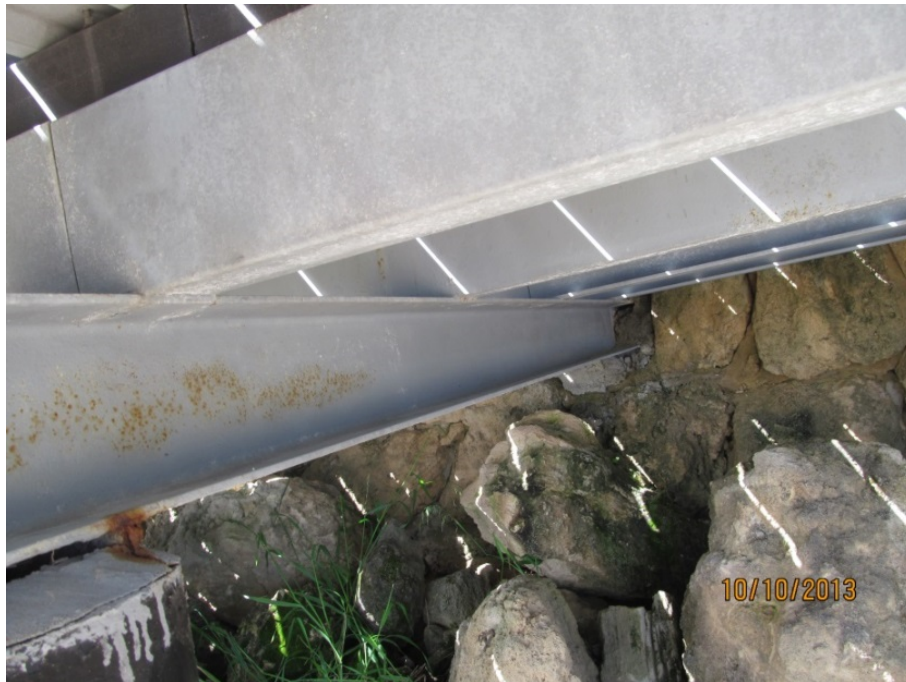
In the existing northeastern section of the boardwalk, there is pile support for the riverside of the boardwalk, with the steel cross beam which connects being supported in a recess into the limestone retaining wall on the land side. This connection was unstable as the retaining wall was rotating due to erosion issues below the boardwalk. This meant that new supports were needed to avoid reliance on the retaining wall for support.

Figure 4. Steel Cross Beam Embedded in Retaining Wall.

Where the boardwalk cross beams were embedded in the limestone retaining wall adjacent, it was proposed to support them on new GFRP reinforced concrete columns identical to the replacement columns.
