PRESENTATION ON INVESTIGATION OF PIPELINE FAILURE

ABSTRACT: Investigation of the causes of failure of a large diameter, high density polyethylene (HDPE) pressure pipeline. The conduit is a 25km long, 650 to 800mm diameter HDPE buried irrigation pipeline, installed parallel to the Gascoyne River in WA. The pipeline failed during testing in December 2016. Investigations included inspection of the failed pipe length and determination of the cause of rupture of the 32mm thick pipe wall. Failure included ballooning (yielding of the pipe wall) with resulting rupture. The factors that were investigated included stress capability of HDPE material, earth loading, temperature, excessive internal static pressure, air entrapment, hydraulic surge and duration of test pressures. Following the investigation, the remediation included replacement of the failed pipe length and improved testing procedures, including having the pipe refilled, and pressure tested at 450 KPa.

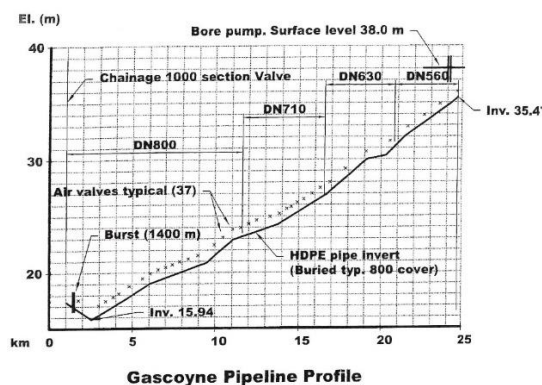
Figure 1.

Figure 1 indicates the profile of the pipeline. The pipeline is a pressure conduit designed for direct delivery of variable flow rates. The estimated maximum operating pressure at the lower (west) end was forecast to be 40 m. The test pressure was specified to be 60 m (600 kPa).

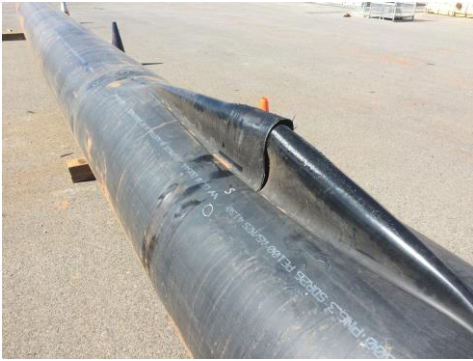
Photograph 2: is a photo of the failed length of pipe after it was transported to Perth for detailed inspection and testing.

Inspection of the failed pipe indicated that the pipe wall had yielded from an average thickness of 31.8 mm to 5.2 mm before final rupture. The yield was equivalent to about 612 %. Published test data for HDPE indicates that elongation prior to rupture is typically 636 %. At the time of the failure it was estimated that ground temperature adjacent to the pipe would have been in the range of 30 to 35° C which could have lowered the pressure rating of the pipe by about 10 % (from 630 kPa to approx. 580 kPa).

Based on inspection and measurement of the yielded pipe wall, it was obvious that the pipe had failed due to excessive internal pressure.

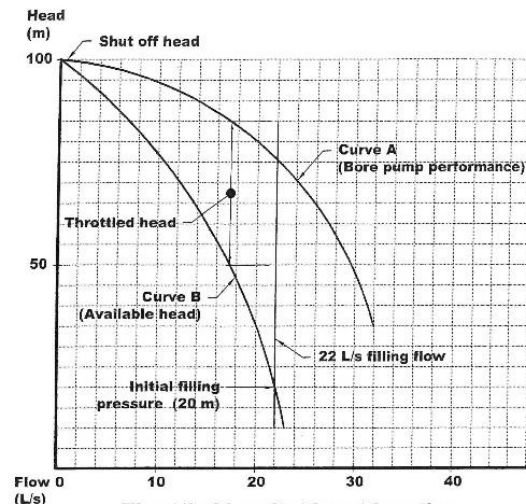
Figure 2: Throttled head at burst location

Curve A on Figure 2 indicates the head capacity curve of the bore pump. The curve is based on the bore pump manufacturer’s performance curve and it was adjusted to account for bore drawdown and actual static lift [3].

Curve B on Figure 2 indicates the available head that could be transferred to the pipeline after passing thru the throttling valve. On the day of the final filling, the throttling valve was adjusted so as to initially limit the inflow to 22 L/s. All section valves along the length of the pipeline were open and the **applicable pressure from Curve B would have gradually been applied (based on the elevation) as the pipeline became pressurised.**

As the pipeline became completely full and the back pressure on the pump increased, pumped flows decreased and the effect of throttling was also decreased. Additional head (due to less effective throttling) would have been applied to the pipeline. **There was no record of actual pipeline pressure at the time of failure.**
