PRESENTATION ON INVESTIGATION OF PIPELINE FAILURE

ABSTRACT: Investigation of the causes of failure of a large diameter, high density polyethylene (HDPE) pressure pipeline. The conduit is a 25km long, 650 to 800mm diameter HDPE buried irrigation pipeline, installed parallel to the Gascoyne River in WA. The pipeline failed during testing in December 2016. Investigations included inspection of the failed pipe length and determination of the cause of rupture of the 32mm thick pipe wall. Failure included ballooning (yielding of the pipe wall) with resulting rupture. The factors that were investigated included stress capability of HDPE material, earth loading, temperature, excessive internal static pressure, air entrapment, hydraulic surge and duration of test pressures. Following the investigation, the remediation included replacement of the failed pipe length and improved testing procedures, including having the pipe refilled, and pressure tested at 450 KPa.

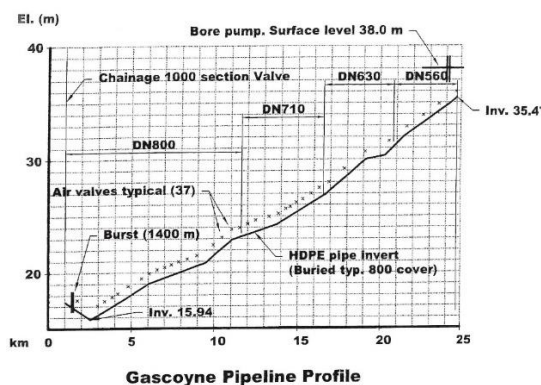
Figure 1.

Figure 1" indicates the profile of the pipeline. The pipeline is a pressure conduit designed for direct delivery of variable flow rates. The estimated maximum operating pressure at the lower (west) end was forecast to be 40 m. The test pressure was specified to be 60 m (600 kPa).

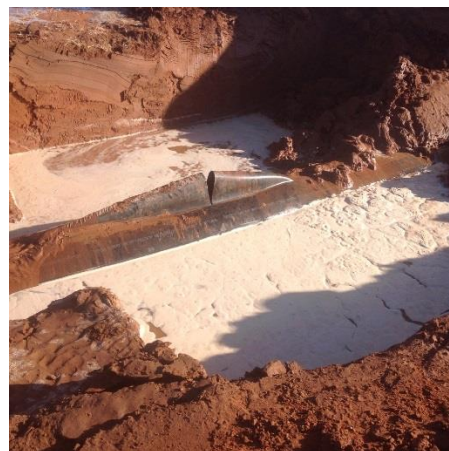
The pipeline failed during the final filling operations on 19 Dec, 2016. A length of 800 nominal diameter PN6.3 pipe (inside diameter approx. 736 mm) yielded along the crown of the pipe and subsequently fractured. The failure was near the lowest point of the pipeline (invert approx. 16 .5 m AHD).

Photograph 1: is a photo of the failed pipe in the trench before dewatering and removal.
