Hay St Perth Art Deco Heritage; Carbonation And Chloride Observations; Restoration And Adaptive Re-use

Anthea L. Airey¹

¹Expert Scientist of Airey Taylor Consulting

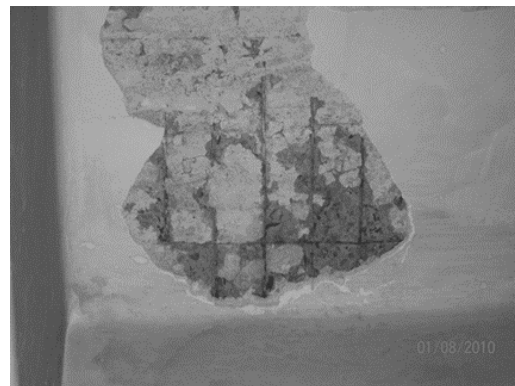
Figure 2. Reinforcing Mesh Level 2 ceiling

The slabs were reinforced with a mesh which was on the soffit side at a depth of approximately 10 mm (varying 0-20 mm). To this was adhered a thick 10 mm plaster (Figure 2). To investigators surprise a layer of sand was found in and above the plaster adhered to the concrete suggesting the concrete may have been cast with a fine blinding layer on a plaster already prepared on the formwork. The low cover approach may have been used as a shrinkage management measure of the concrete surface or possibly intended as a combined plaster reinforcement in addition to the concrete reinforcement. The Battye Library photo (Figure 1(a)) confirms this low cover. At time of inspection, areas not affected by water the plaster was still adhered and reinforcement was found to be quite shiny (passive) or grey consistent with galvanising.

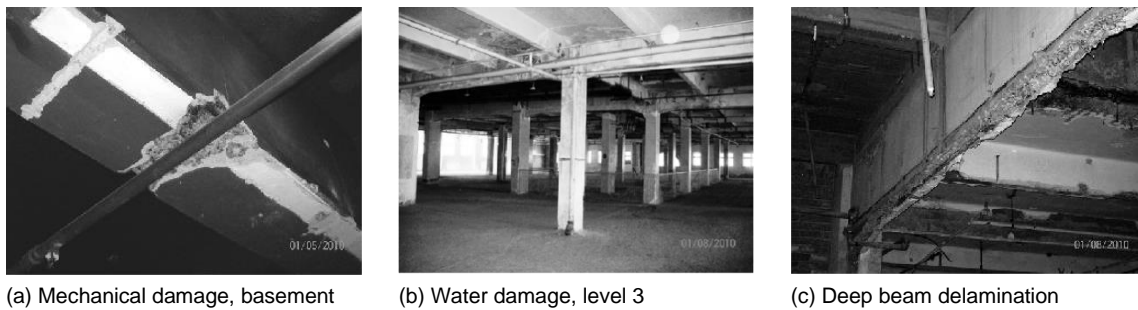
Figure 3. Damage to Beams, 726 Hay St

The construction of 5 levels plus a basement was assessed by Airey Taylor Consulting (ATC) in 2004 as part of the Metrorail City project identifying it to be a primarily steel-framed structure encased in concrete, with secondary reinforced concrete beams with reinforced concrete floors (25). This and other studies by ATC found that in circa 1961 a new slab at level 4 (roof) had been suspended over the old roof slab upon which to establish the tea rooms and new concrete roof structure upon which a plant room was built at level 5. Over time, leaks at the escalator skylight allowed water to move within a double slab arrangement on level 3 roof/level 4 slab from the extensions, down the restraint cracks soaking through the slabs and thence into beams and columns at levels 3, 2 and 1. Thus, ordinarily indoor concrete had been subject to a number of years of weathering. Particularly at level 3 this resulted in delamination of the underside of the beams (Figure 3 (c)).

Some surprising results ensued, which was an absence of carbonation on painted, plastered vertical faces of both the 1921 and 1961 beams and column 2. Carbonation had occurred on the interface of the steel beam and the concrete encasement of the 1961 beam¹⁴; but not the plastered side. Some finely carbonated in some voids in the 1921 concrete. The generally poor condition of the underside of beams on level 3 and steel encased beams of level 4 was attributed to poor consolidation allowing surface corrosion to delaminate the underside when wet; steel had lost no substantial section enabling re-use.

A patch repair was inappropriate for the deep beams. To restore their integrity following reinforcement cleaning and application of epoxy zincrich primer a form and pour methodology was specified requiring a pre-soak let out with a tap, followed by reinstatement with a super fluid, high strength, low alkali, micro-concrete reinstatement agent was poured in with venting for air to be displaced so that voids in the concrete do not form, through specially prepared formwork with spouts. The forms were to be left on for the cure period (Figure 5 (a) and (b)).

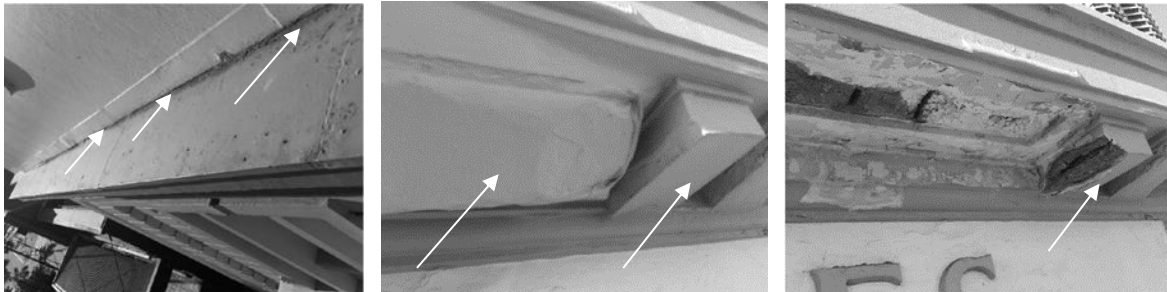
At Bank of NSW corrosion at the base of a discontinuous flashing on the upper cornice (acting as an awning for the windows below) was noted (Figure 7 (a)). A cherry picker employed to investigate finding the bulging on soffit side due to water (Figure 7 (b)). Tap testing found a series of loose and delaminated pieces of concrete soffit and steel reinforcement within (Figure 7 (c)).

(a) Water ponding at discontinuous flashing

(b) Bulging paintwork

(c) Following removal of loose concrete – arrow indicates sample location

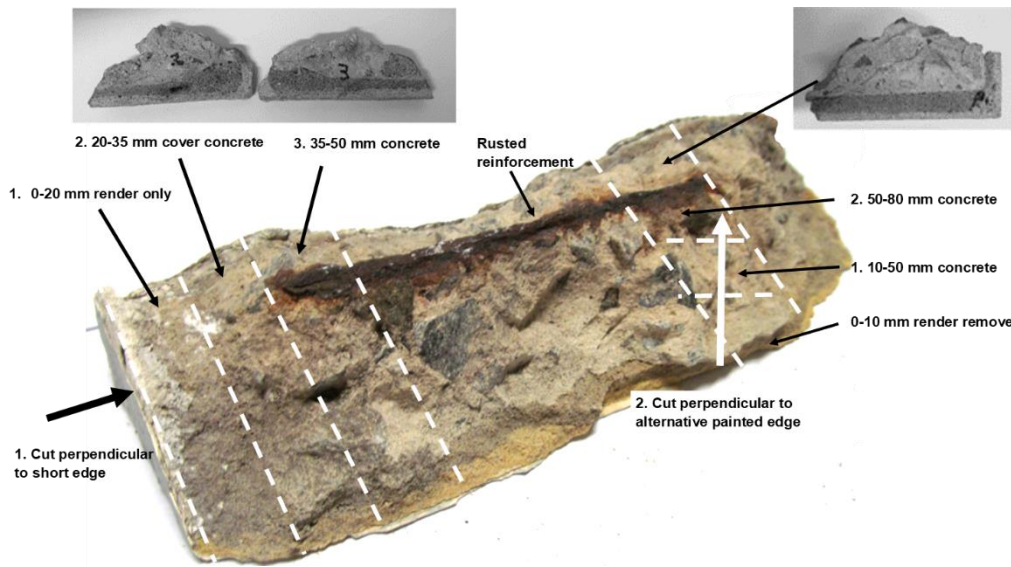
Figure 7. Cutting plan to examine causes of upper cornice spall development and spray results¹⁵

A loose section of a dentil was knocked off and retained (“the spall” Figure 8 overleaf) and the three through-sections of concrete tested by phenolphthalein, representing a cover section (piece #2) and two sections including the reinforcement (Piece # 3 and #1 – right). The concrete was found to be fully carbonated to maximum depth of 150 mm from rendered edge. There were two renders noted, a light coloured outer render 2-5 mm thick and a dark render 3-12 mm thick. Some very light pink stains were noted in the outer layer. The chloride results are reported in Table 6.

The Bank of NSW results strongly support that carbonation was required for the depassivation rusting and subsequent near-delamination of the spall. The dentil had long term exposure to the original chloride present as an accelerator, however there have been no spalls apparently due to this in the previous eighty two years. Unlike the Dynon's China Hall building, there was no protective render on the topside, and the flashing did not protect the topside or back corner. It is clear that there was abundance of water traversing the awning in recent years. The critical factor in rusting appears this water in conjunction with the fully carbonated state.
