PRESENTATION ON FAILURE OF BELLY DUMP TRAILERS

There are some forensic investigations which cross the boundaries between Mechanical and Structural Engineering. The investigation of the failures within Belly Dump Assembly's used to transport 150cu.m of product in the assembly shown in the diagram presented was investigated. The loads and general proportions of the assembly are shown pictorially in the diagram presented on the screen.

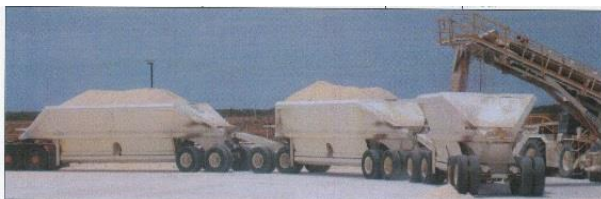
Photograph 1: 2 Trailers & Dollies Next to Loader

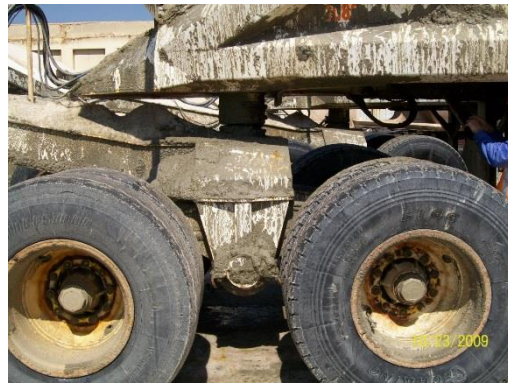
I inspected the facility and is shown on the photograph now on the screen.

Photograph 2: coupler structure between wet haul trailers or of the hitch turret

The interesting thing about the failures viewed is that they are through the metal and not the welds. The actual failure viewed by me was of the draw bar at the rear of the leading trailer on a Belly Dump Truck. The picture on the screen shows the failed (snapped) linking arrangement between the two trailers with a Dolly with turret over plus cantilevering arm which connected to the leading trailer by an articulated ball. A closer view of the failure is shown on the screen.
