Hay St Perth Art Deco Heritage; Carbonation And Chloride Observations; Restoration And Adaptive Re-use

Anthea L. Airey¹

¹Expert Scientist of Airey Taylor Consulting

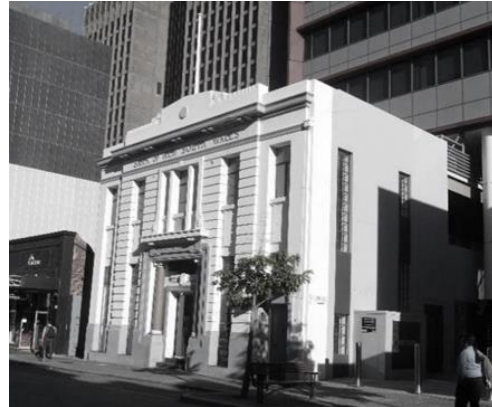
Figure 6. Bank of NSW Building

At Bank of NSW corrosion at the base of a discontinuous flashing on the upper cornice (acting as an awning for the windows below) was noted (Figure 7 (a)). A cherry picker employed to investigate finding the bulging on soffit side due to water (Figure 7 (b)). Tap testing found a series of loose and delaminated pieces of concrete soffit and steel reinforcement within (Figure 7 (c)).
